The Road Inventory of Leavenworth National Fish Hatchery Leavenworth, WA

Prepared By:
Federal Highway Administration
Central Federal Lands Highway Division
April 2013

Leavenworth National Fish Hatchery ROUTE LOCATION MAP

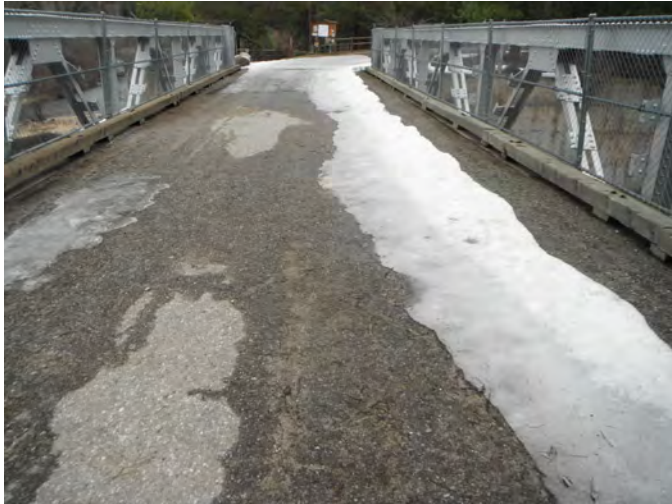
Photo: LEAV_C4_0102 Route: 401-001-0.06
Concrete Bridge NBIS:000013225-0003
Asset# 10002582

Leavenworth NFH - 13225 Bridge Inventory					
Rte #	Milepost	NBIS #	Sufficiency Rating	Functionally Obsolete	Structurally Deficient
401	0.06	000013225-0003	609	N	N
